City of Markham Case Study

Municipal Corporate Energy Efficiency Case Study
March 29, 2017

Milliken Mills CC Profile

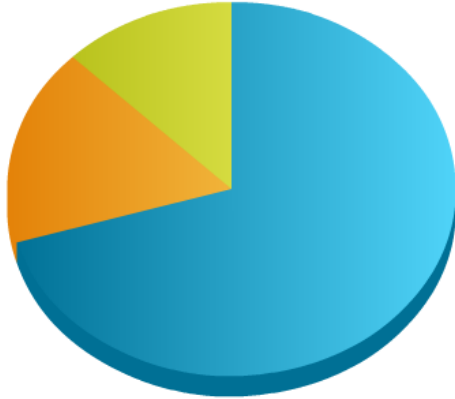
Energy Cost Percentage

- Electric 70.3%
- Natural Gas 17.1%
- Water 12.5%

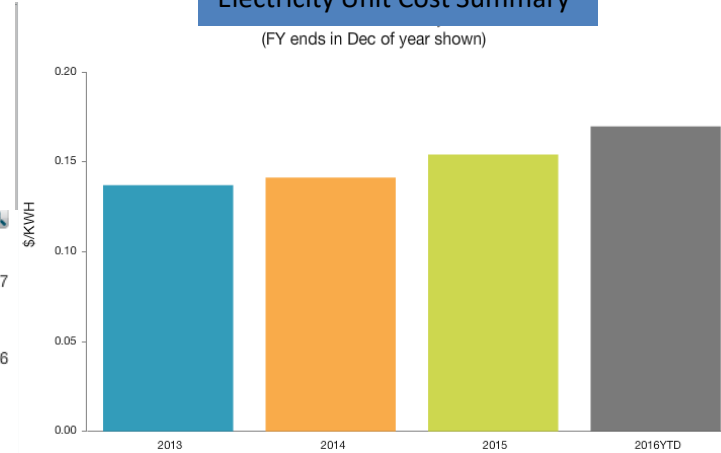
Electricity Unit Cost Summary

(FY ends in Dec of year shown)

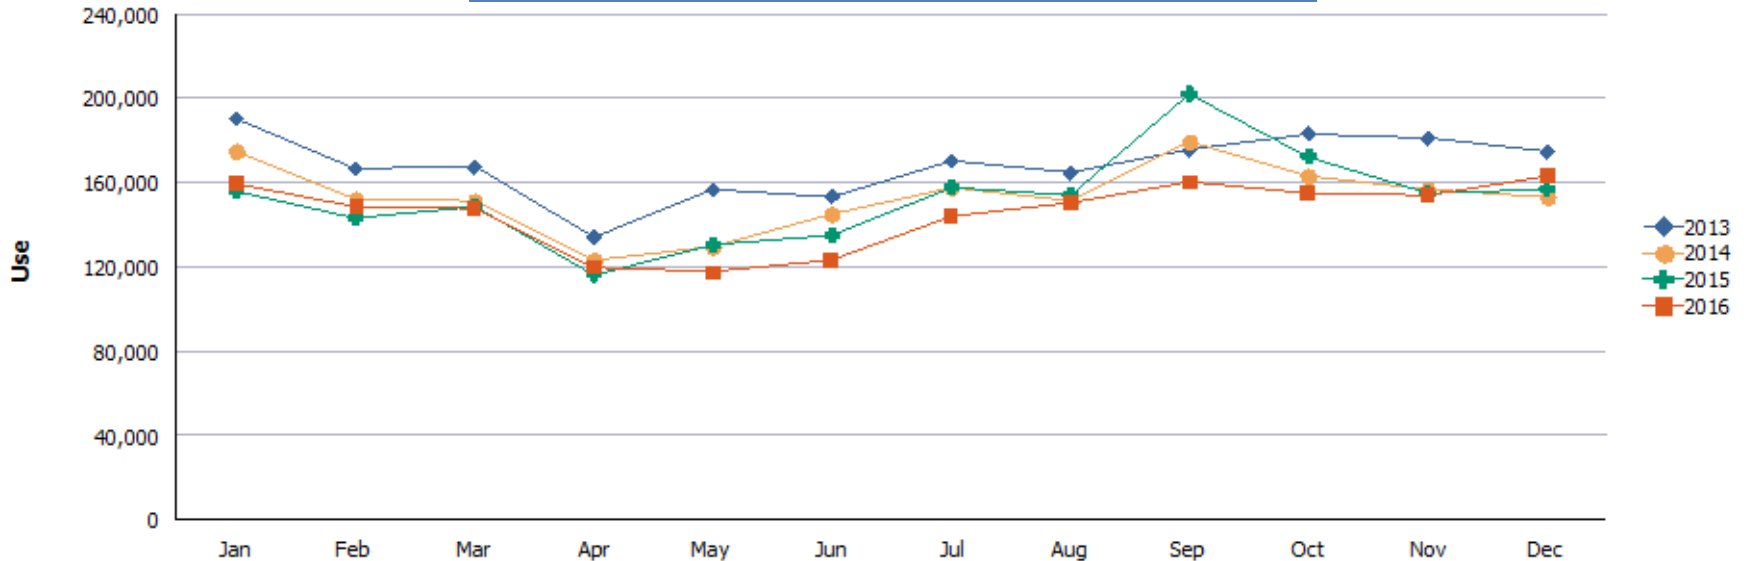
Milliken Mills CC – Electricity Profile

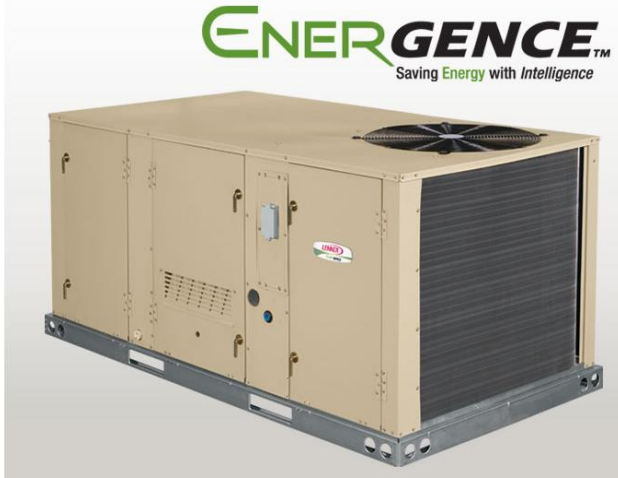
High Efficiency RTUs (2015)

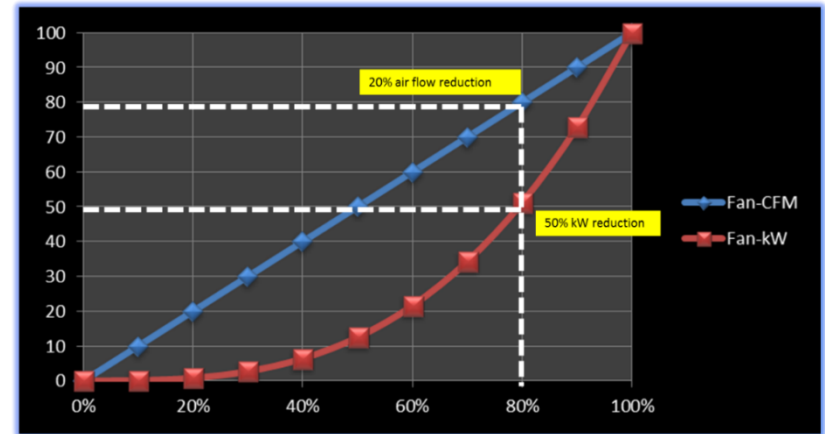
VFDs (2010, 2015)

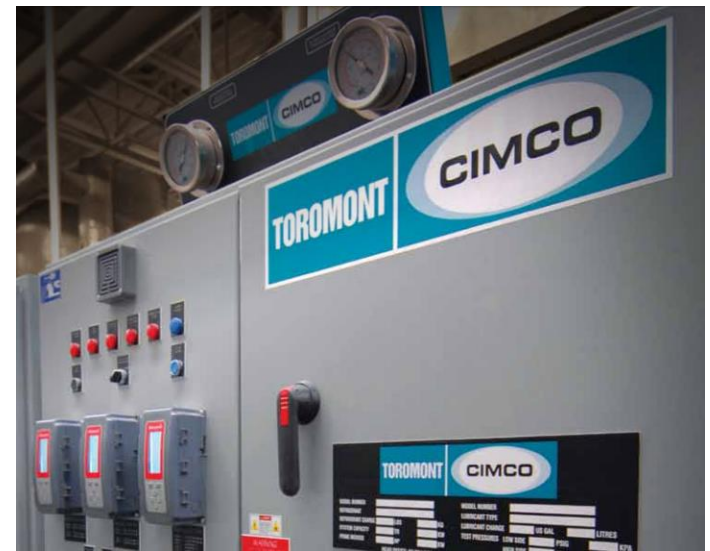
CIMCO 6000E (2010)

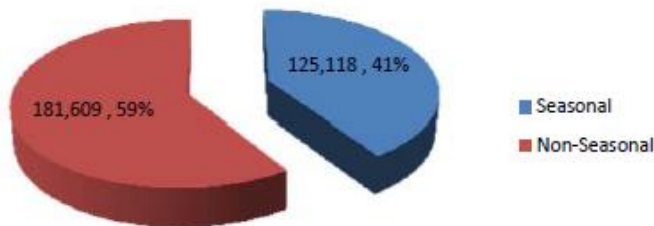
Baseline Natural Gas Consumption (m3)

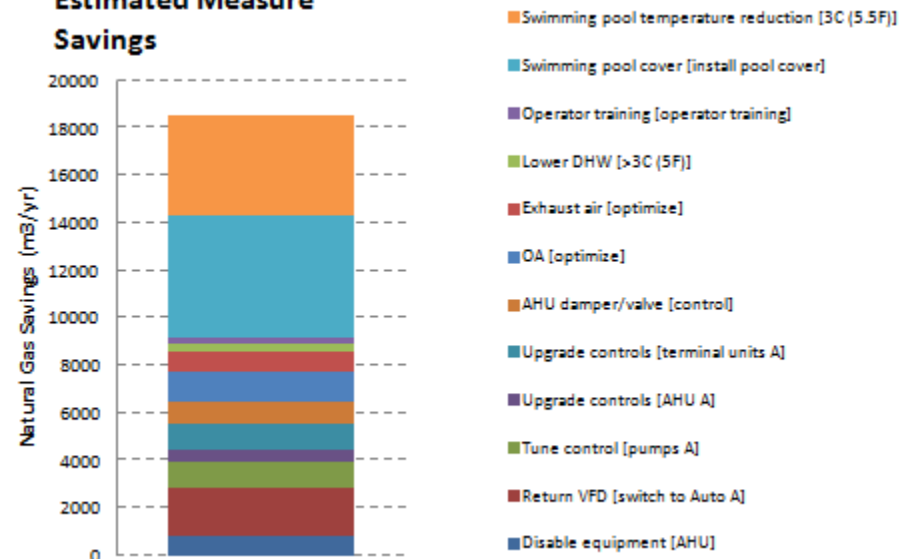
Estimated Measure Savings

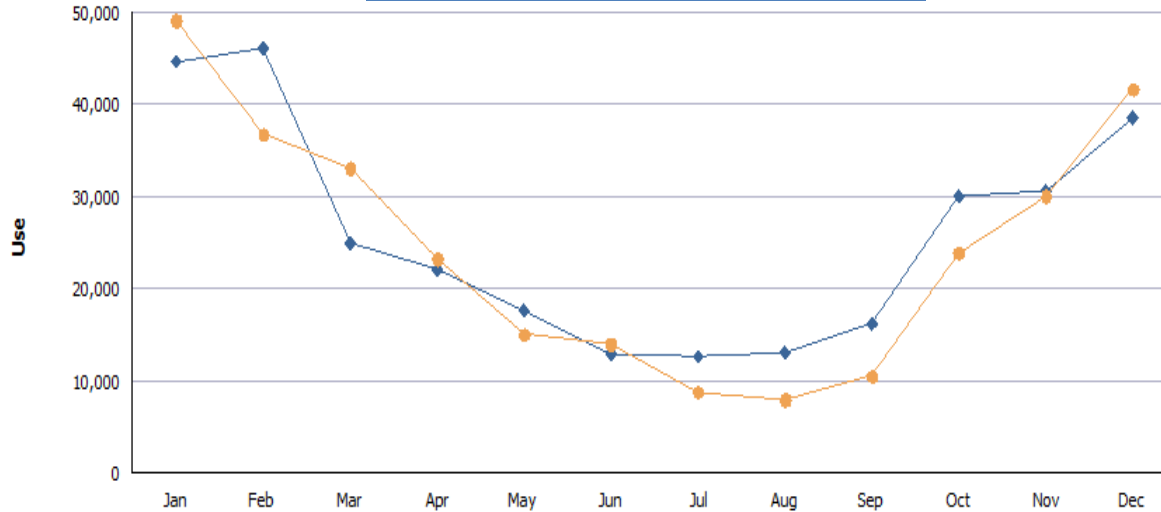
Milliken Mills CC – Gas Profile

Milliken Mills CC: All Year, Indoor
Savings = 15,000 m³/yr (\$4,000/yr)
Cost = \$3,960/yr

◆ 2015
● 2016

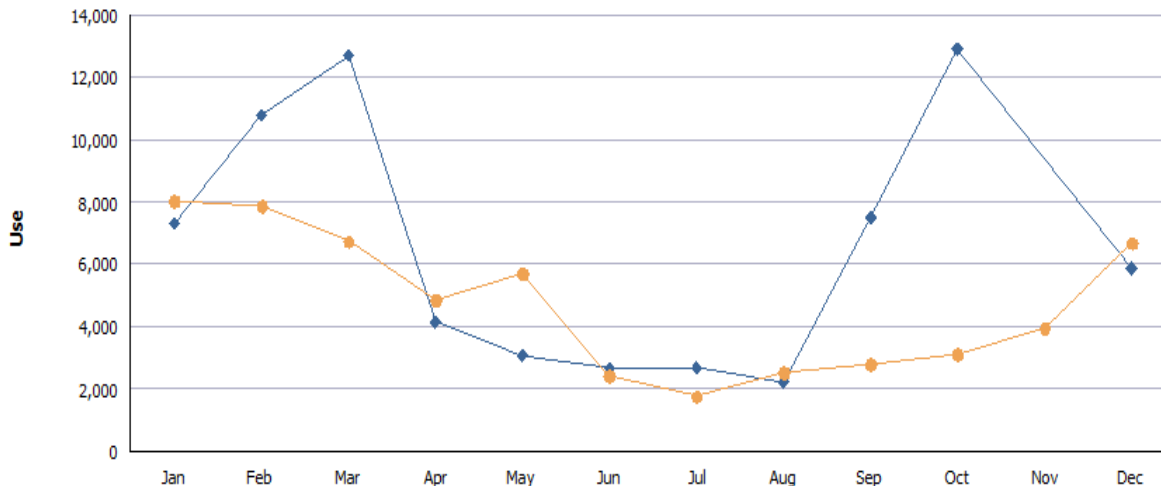
Rouge River CC – Gas Profile

Rouge River CC : June – Sept, Outdoor
Savings = 3,500m³/yr (\$910/yr)
Cost = \$660/yr

◆ 2015
● 2016
